**HIGHWAY 417 WEST A
EMERGENCY WATERMAIN REPAIR**

Presented by
Lee-Anne Truong (City of Ottawa)
Graeme Stewert (Robinson Consultants)
Joe Skrepnek (Tomlinson Construction)

THE BREAK – NOVEMBER 14, 2024

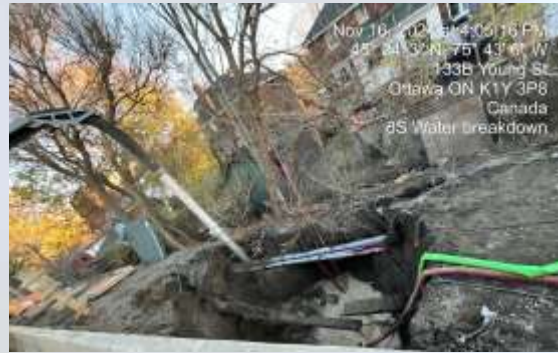
THE BREAK SITE

- MTO installing noise wall along HWY417
- Damage to 5 Properties (basement water damage and mud in backyards)
- DWS isolated the 1220WM to stop the leak
- MTO Dewatering the break site

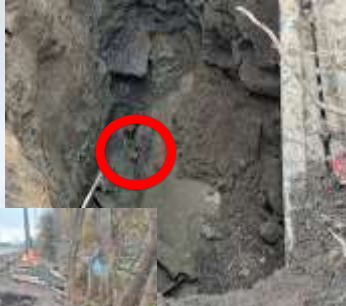
- MTO Hydrovaced and exposed the WM
- Obtained MTO Data including Geotech info, vibration monitors, noise wall post locations
- Completed additional boreholes

Break located by MTO Contractor Nov 20, 2025

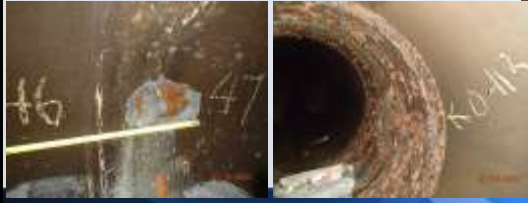
CFRP LINING PREP
Manned Inspection (Jan 15-24, 2025)

- Manned Inspection completed between Holland to Loretta
- Recommendation to repair four pipe
 - 2 at the break site
 - 1 showed longitudinal cracks
 - 1 showed concrete spalling
- Several anomalies along the pipe but these were recommended to be monitored

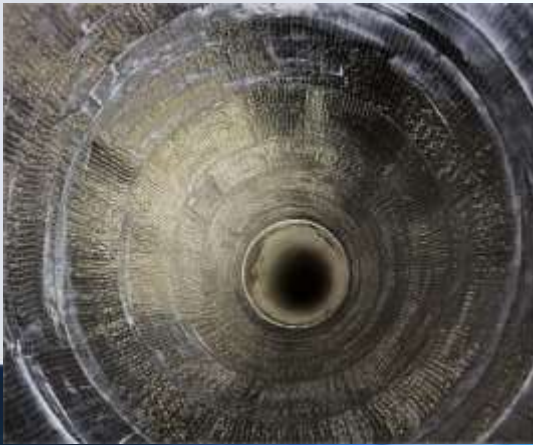
THE PIPES ARE FIXED!

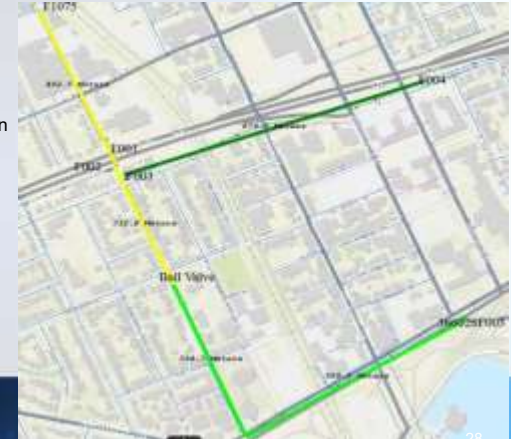
**COMMISSIONING**

- Started March 12, 2025
- Priority Loretta line: Back in service (Yellow and light Green)
 - DWS was able to force open the Ball Valve
 - Commissioned in time for Max Day
- Emergency status was lifted
- The saga is complete
