**HIGHWAY 417 WEST A
EMERGENCY WATERMAIN REPAIR**

Presented by
Lee-Anne Truong (City of Ottawa)
Graeme Stewert (Robinson Consultants)
Joe Skrepnek (Tomlinson Construction)

THE BREAK – NOVEMBER 14, 2024

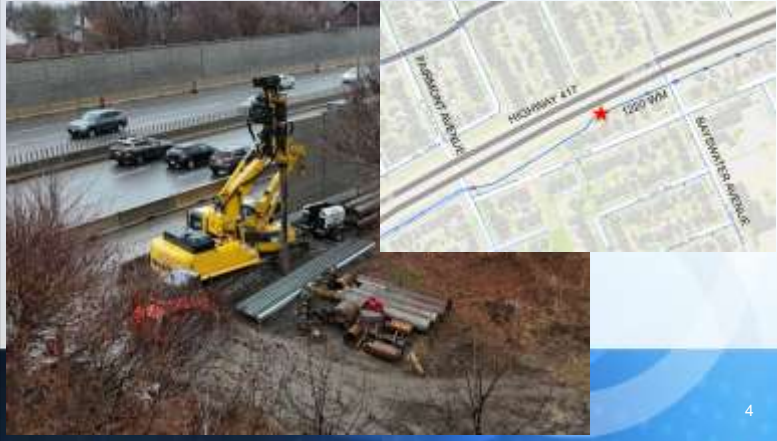
THE LOCATION: HWY 417 BETWEEN FAIRMONT AND BAYSWATER

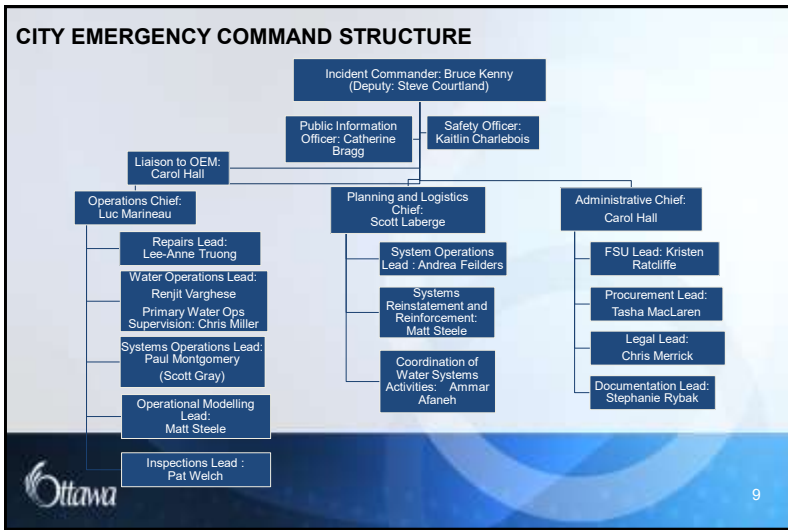
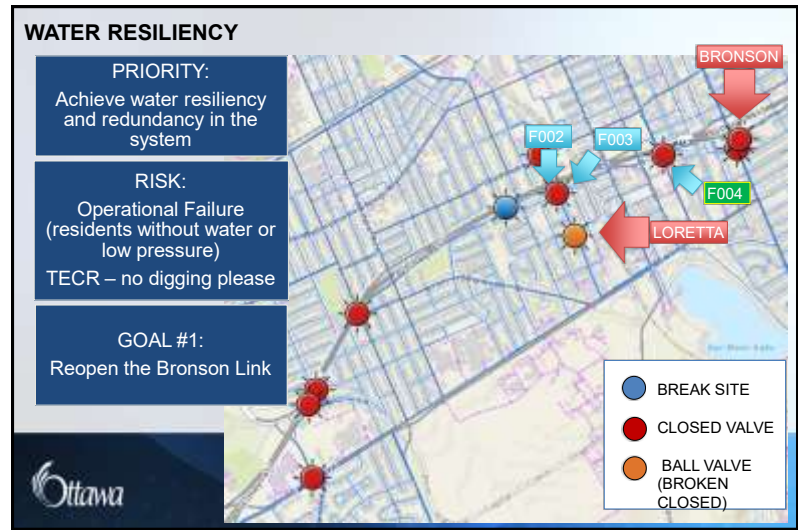
WM RESILIENCY – CLOSE VALVE F004

- Valve F004 - Seized Valve, rusted gear box
- Located on the Highway side slope of Orangeville Street, where MTO is staged

EXERCISE AND WATERJET VALVE F004 TO GET A GOOD SHUT

Move KDMP's material out of the way.
Coordinate with MTO to work on this site.

Build a ramp to fit DWS hydraulic valve turning truck

Control up to 100L/s of discharge to prevent water from entering the break site.

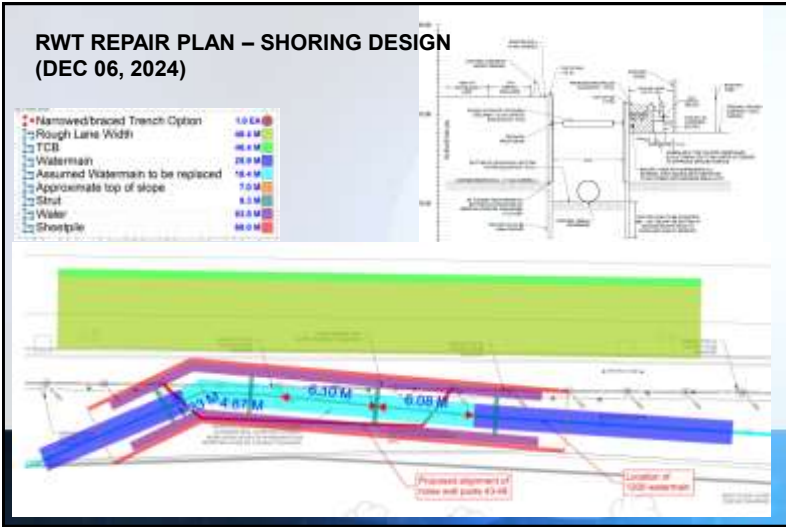
WATERMAIN REPAIR – OPEN CUT

REPAIR PLAN	RISKS
Location – challenging, between 417 and private properties with a steep side slope MTO Approvals Required <ul style="list-style-type: none"> • Traffic Staging Plans • Site Access Plans • ATMS Cable conflict / Utility Coordination • Design Approval • Encroachment Permit Health and Safety / MOL MTO Site Hand over	<ul style="list-style-type: none"> • Location of WM bend West of break location not certain • Damage to adjacent properties • Shoring (sheet piles) near the WM • Undermining HWY417 • Work site on HWY 417
